# Manhole Inspection Summary

Manhole # S15II1030MH

Insp Date: **7/15/07 1:57 AM**

**Location** Address: **COLD SPRING LN**

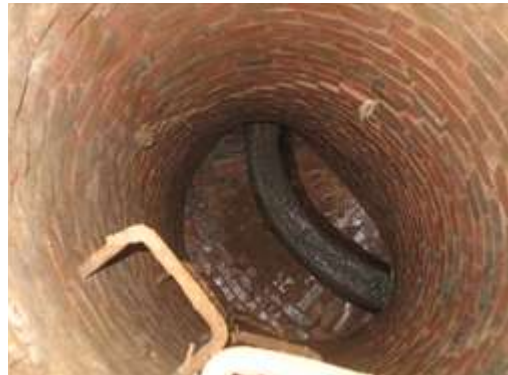
Top View

Corbel and Barrel cracks. Corroded steps. Evidence of surcharge - Bench debris.

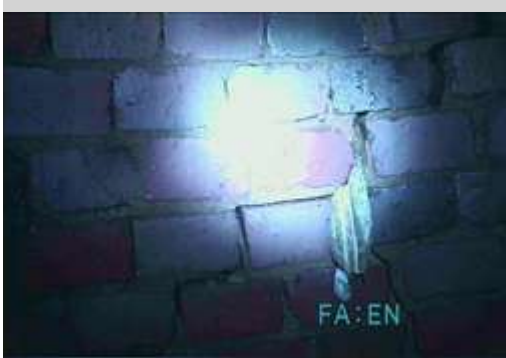
Defect

Corbel cracks and infiltration. Evidence of surcharge.

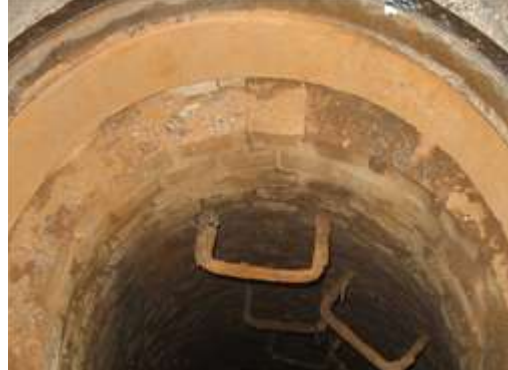
Defect

Frame leaks. Frame offset. Adjustment deterioration and infiltration.

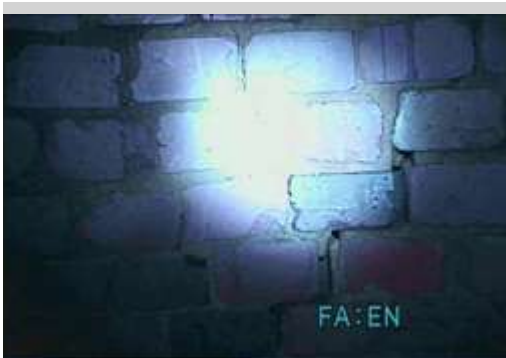
Defect

Barrel cracks.

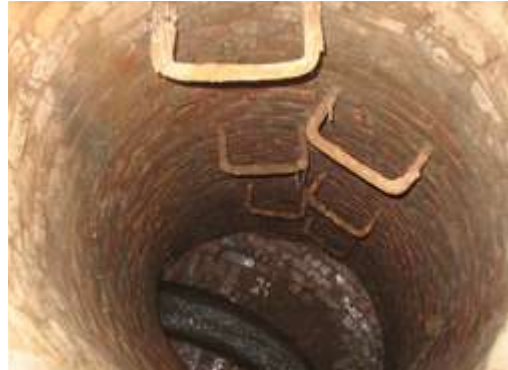
Defect

Adjustment and Barrel infiltration.

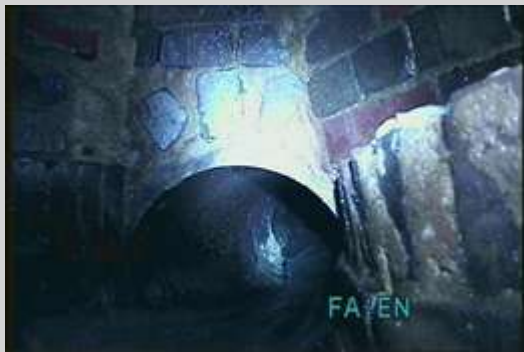
### 12 in. Circular Gravity Sewer Pipe Out @ 12 O'Clock

Invert Depth: **13.82** (ft.) Flow Characteristics: **Fast**

Deposits: ☒ None ☐ Mud ☐ Sludge ☐ Debris ☐ Grease

Infiltration: **None** Pipe Seal Cond: **Unknown**

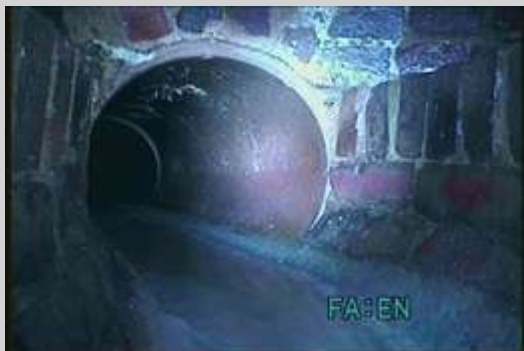
### 12 in. Circular Gravity Sewer Pipe In @ 5 O'Clock

Invert Depth: **13.28** (ft.) Flow Characteristics: **Fast**

Deposits: ☐ None ☐ Mud ☐ Sludge ☐ Debris ☒ Grease

Silt Depth: **0** (in.) Deposits Extent: **Light**
